# Family Heirloom

*After a second life as a mild hot rod, and decades of storage, a full restoration is bestowed upon a 1931 Ford Model A Pickup—Part I*

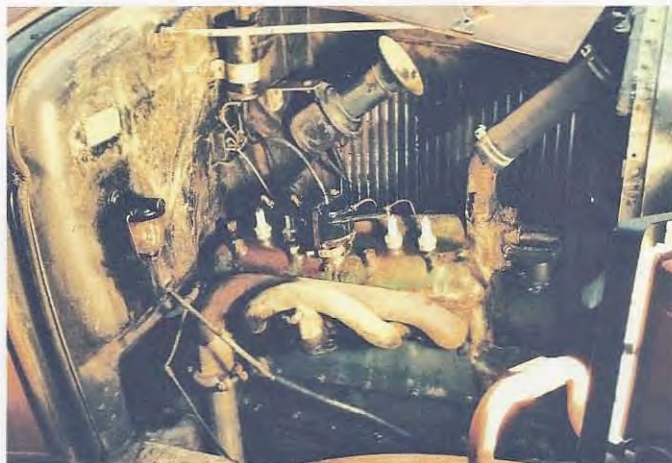
The closed-cab pickup, designated model 82-B by Ford, was meticulously evaluated during its disassembly. Looking worse for wear—though in sound, running condition—was its original 201-cu.in. four-cylinder engine, rated for 40 hp at 2,200 rpm.

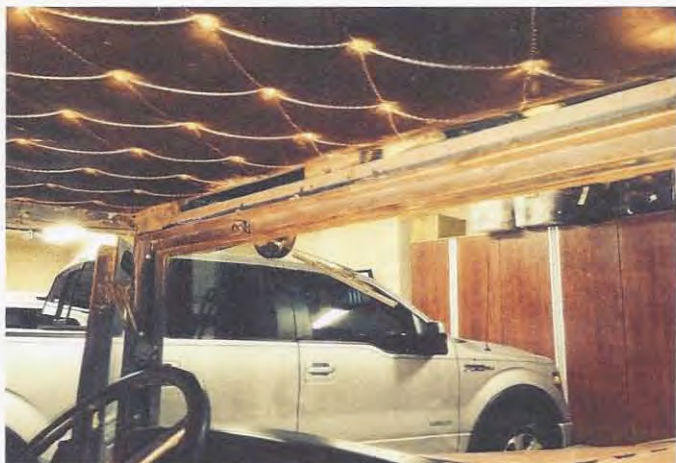
At the top of this image you'll see the diamond-pattern upholstery installed in Mexico decades prior. The pivot points and slide braces for the front windshield were functional, as was the wiper motor, but the wooden header above showed water stains.

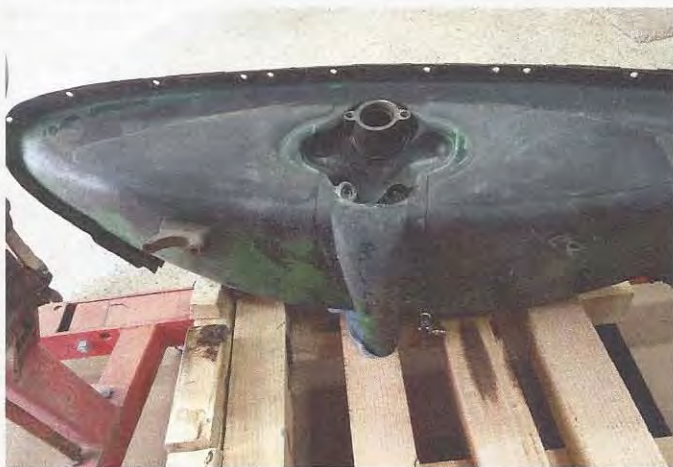
1931 was the last year Ford used a gravity-fed fuel system, hence the combination fuel tank/cowl design. This is the underside of the unit, which, upon inspection, was seen to be devoid of corrosion. The tank within required professional cleaning.

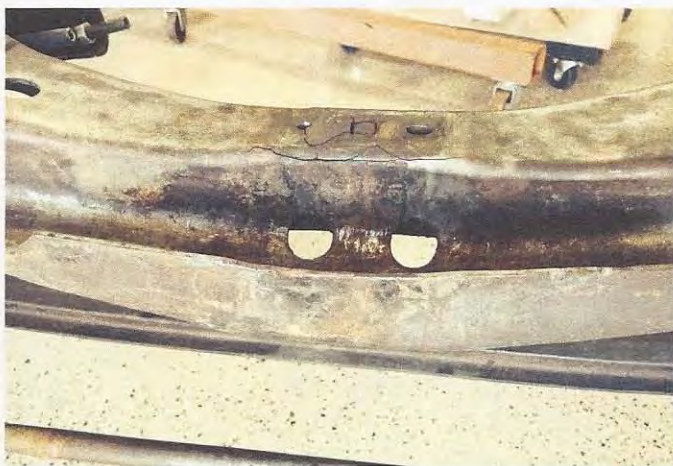
Overall, metal damage was exceptionally minimal, but there were a couple concerns to address. These are stress cracks found on the front crossmember where the front semi-elliptic leaf spring is mounted from below. They were rectified via welding.

After media blasting, repairing the front crossmember, and checking frame geometry, the steel structure was finished in gloss black via powder coating, which tends to offer more durability and shorter cure times. It's also a more cost-effective method.

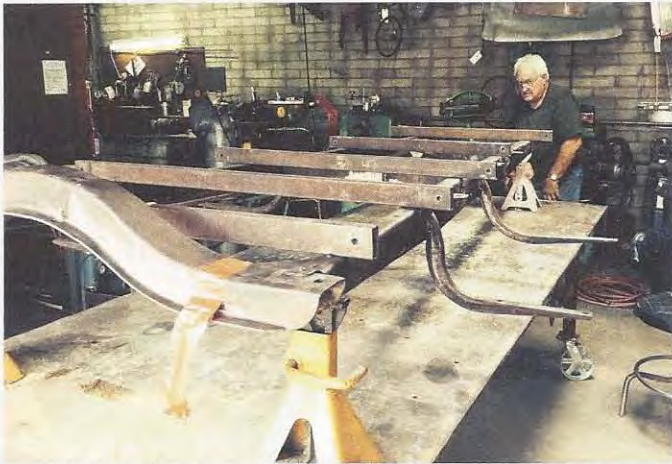
Local Model A Club members recommended that the frame should be checked for straightness and against factory tolerances, which is underway here. Any twisting would have to be corrected before work could continue, but the frame was found to be true.

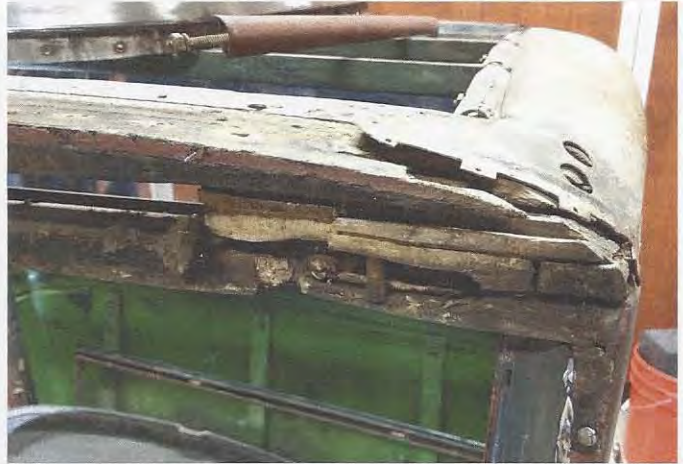
While the frame was being checked, focus shifted back to the cab. After removing the factory visor, a standard feature, it was discovered that a section of the wood framing—still employed to support the fabric top—had suffered the wrath of dry rot.

The remaining wooden roof structure appeared to be sound; however, after consulting knowledgeable Model A enthusiasts, it was recommended that all the wood within the cab be replaced with new pieces. Fortunately, dry rot had not affected the steel supports.

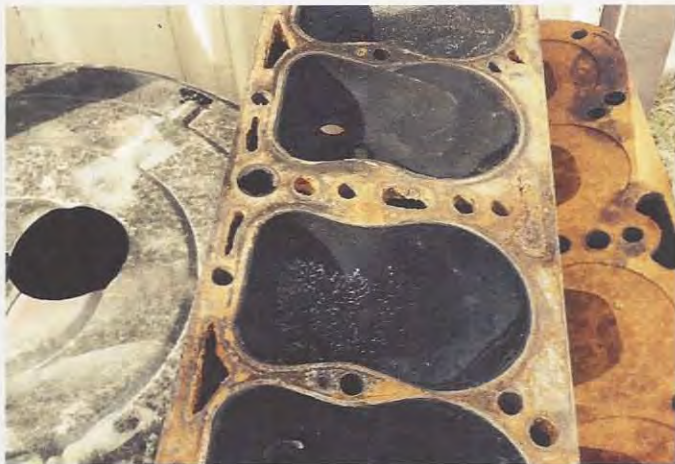
After its removal from the block, the cylinder head was inspected for cracks; several were found within the L-head. Minor corrosion seen within the water passages could be eliminated, but the fractures forced the search for a replacement.

A major step in the Ford's restoration is about to be accomplished here with the test of the fully rebuilt engine and transmission. The former of the two now wears a high-compression L-head; its only modification. The latter required new bearings and seals.

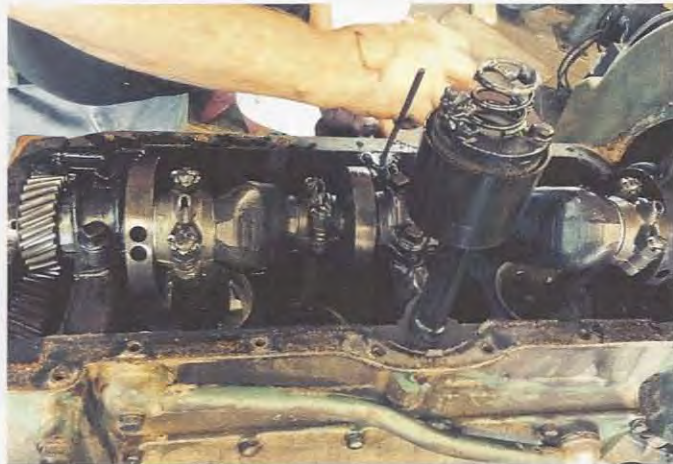
Further engine disassembly continued with the removal of the oil pan, exposing the crankshaft and associated babbitt bearings. Although the prior rebuild was decades old, only 2,000 miles were traveled prior to its decades-long slumber, so wear was minimal.

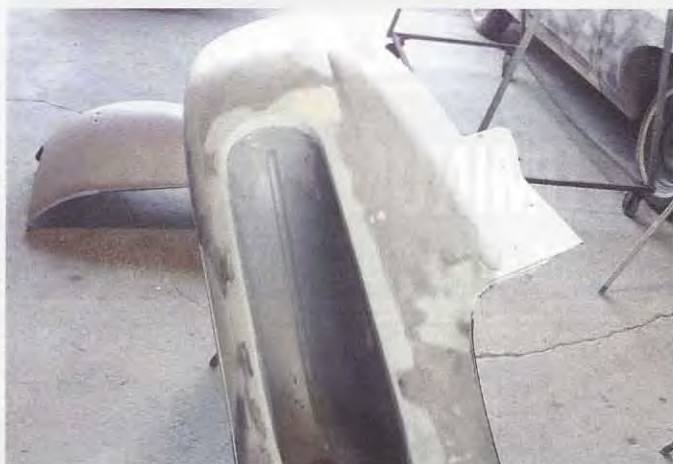
As the chassis received its restoration work, the body was tended to by an associate. One task was returning the spare tire well to the left-front fender. A reproduction piece was welded into place. After sanding, a skim coat of filler hid the seam.
