# Family Heirloom

*After a second life as a mild hot rod, and decades of storage, a full restoration is bestowed upon a 1931 Ford Model A Pickup—Part I*

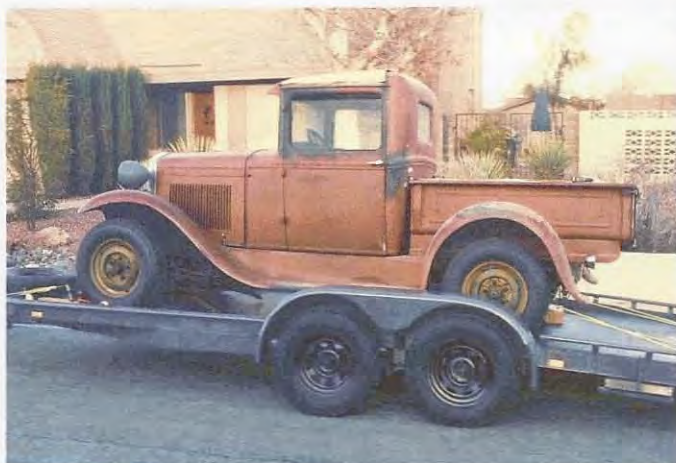
Early March 2015, the Ford is relocated from Paul's home in Las Vegas, Nevada, to Kevin's in Chandler, Arizona—after decades of hibernation—still wearing the red rust primer applied in the late Fifties, as well as period post-production add-ons.

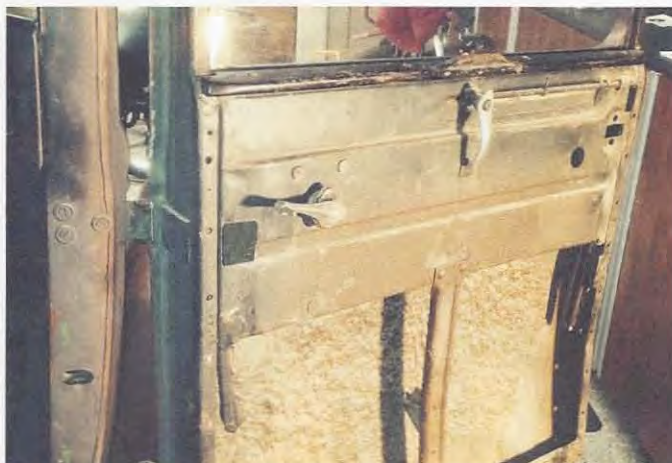
By 1931, the Model A's doors were made entirely of steel. To combat a hollow, tinny noise, a sound-deadening material was sprayed onto the door skin, which is exposed here. The predominantly dry Southwest climate prevented rust from snacking on the metal.

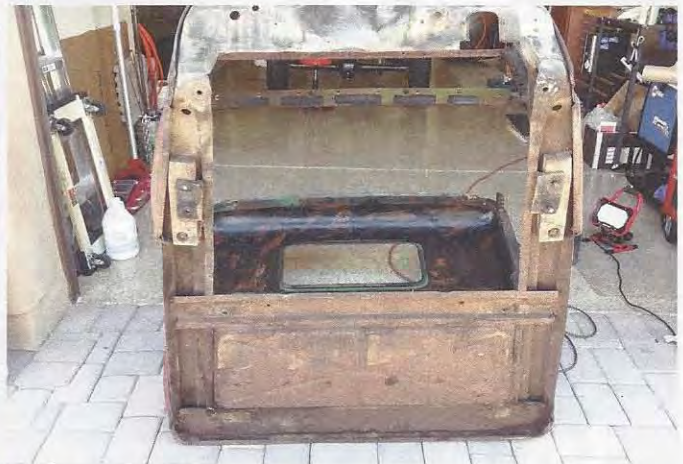
A rotisserie was not available while the pickup was being disassembled, so the underside of the cab—small and lightweight compared to that of other vehicles—was inspected by simply tipping it onto its back. The floor and mounting points were devoid of damage.

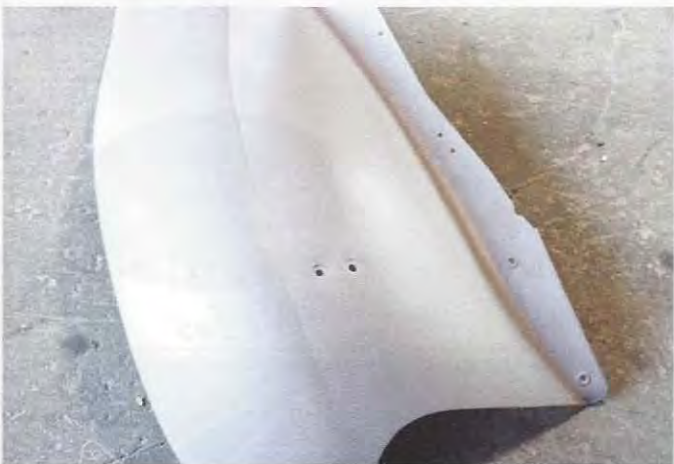
Media blasting uncovered nary a trace of corrosion throughout the body. The fenders, cab, and pickup box were sealed in epoxy primer, before receiving a skim coat of filler. After sanding, the body was given a final coat of primer and was sanded yet again.
